# The Effect of Disc brake Rotor Conditions on Brake Performance

In this paper a study of effect of disc brake rotor condition to the integrity of brake system is presented. Three brake tests are made on GMC Acadia 2008 model, one in a good condition disc brake rotor, two tests in a modified disc brake rotor, to simulate disc brake failure. The first modification of the disc brake was done on right hand side front and rear axle to reface the disc brake rotor 2.5 mm less than the left hand side. The second modification of the disc brake was done also on right hand side front and rear axle by making a groove in the disc brake to simulate bad maintenance or bad condition disc brake. All results was recorded from special device Bosch brake test lanes.

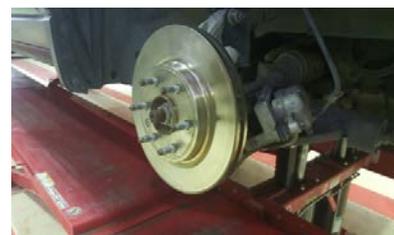
Figure 2: Brake discs for the right hand-side wheels

Then modification of the brake disc rotor of the right hand side wheels is done to induce a fault via reducing the thickness of brake disc rotor to 26.5 mm, which is below the manufacture minimum rotor thickness of 27.5 mm. In a similar manner to Test 1, Test 2 was carried out to examine the friction force on all brake discs. The test carried out for 8 minutes to examine the friction force for the four wheels again under the new condition.

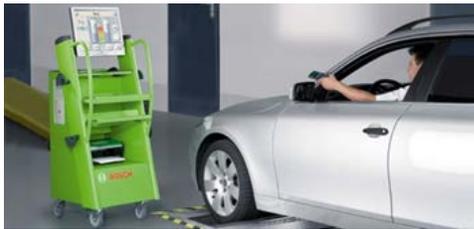
Figure 3: Bosch brake test lanes

Bosch brake test lanes device is used to record the test results and show the strength and performance of the brake system. The device showed three type of results for both the front and rear axles: suspension test, service brake, and park brake tests as shown in Figure 4.

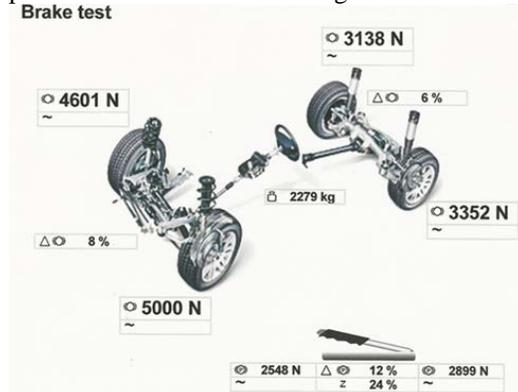
Figure 4: Brake test for good condition brake disc rotor

Through the above tables, it is clear that the Brake Test Lane device can test more than one type of brake test, such suspension test, brake and parking brake. However, the main focus of this research is the brake test. From Table 4 a good condition brake disc generate less than 10% difference in force between left and right brakes. Within this test condition, the car was balanced and successful braking was achieved.

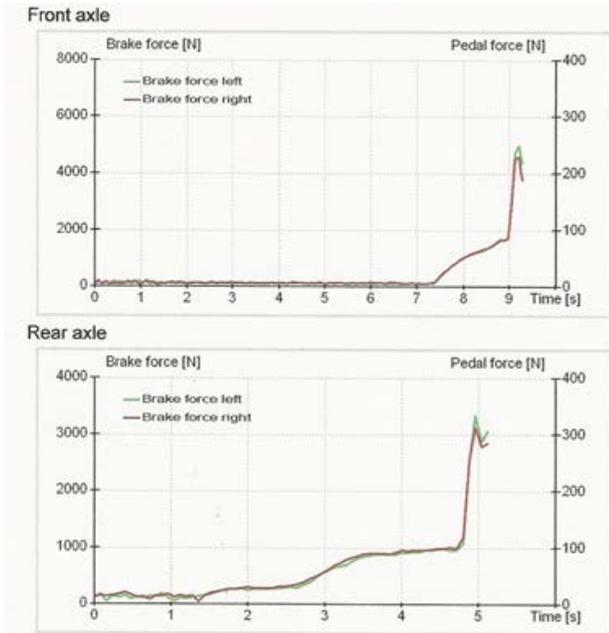
Figure 5: Charts results for good condition brake disc rotor

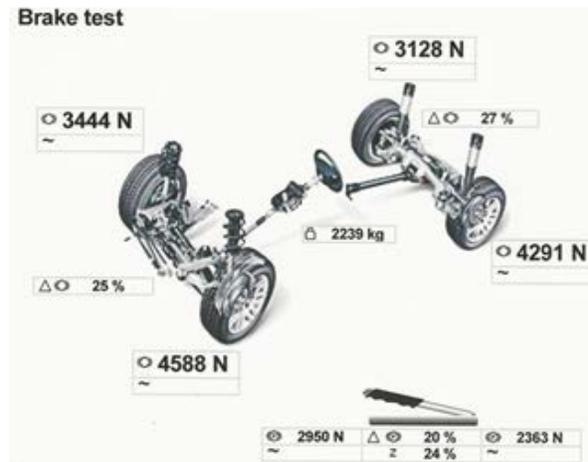
Figure 8: Brake test for modified brake disc rotor thickness

Following the modification that was made to simulate fault in disc brake rotor thickness, the results showed that the brake force difference-service brake ( $\Delta$ ) test for the front axle and the rear axle is between 25 to 27%, which exceed the allowed limits of 25 %. Also the force difference between the right and left wheels for the front axle which is (1144 N), and the force difference between the right and left wheels for the rear axle is (1163 N). From Figure 7, Front axle chart showed peak brake forces that bring the vehicle to complete stop were nearly 3600 N on the left brake side and 2700 N on the right brake side. Whereas the Rear axle chart showed peak brake forces that bring the vehicle to complete stop were nearly 4200 N on the left brake side and 3200 N on the right brake. All of these results indicate big difference that could lead to unbalanced force system.

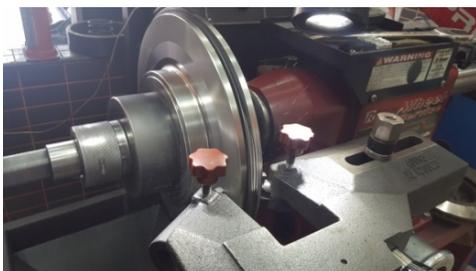
Figure 6: Brake lathe machine to reface the rotor

Attempts to repair the disk brake beyond the manufacturing recommendation can rise risks and therefore should be prevented by regulations to ensure safety for motorists and public. Therefore it is recommended to follow manufacturer recommendations and specifications when disc brake rotor need prefacing by lathe machine. Also when too deep grooves exceeds manufacturer specifications it is recommended to replace the disc brake rotor. Balancing of disc rotor thickness is a must to ensure safe overall performance of brake system prevent brake failure.

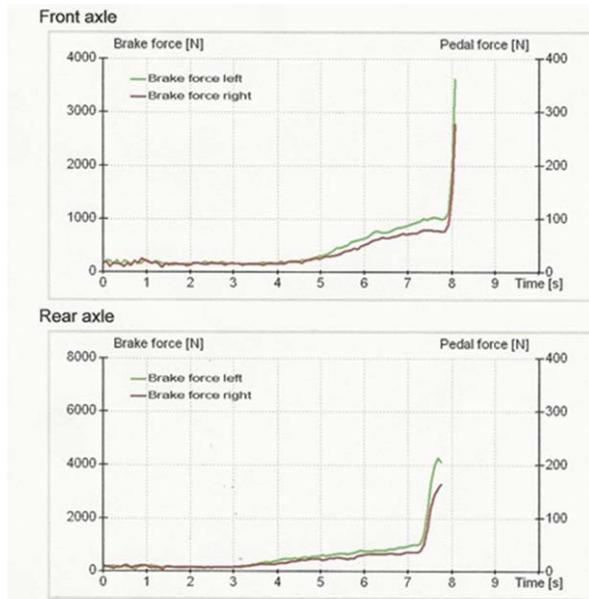
Figure 9: Charts results for modified brake disc rotor thickness

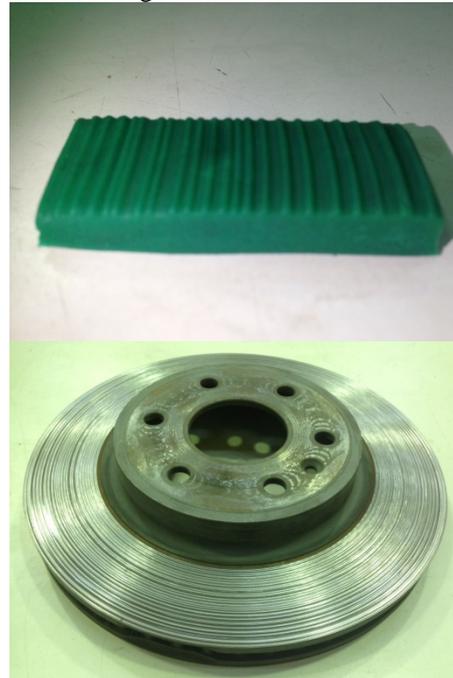
Figure 9: Grooved modified disc brake

In this test, modification of the brake disc rotor of the right hand side wheels front and rear is done to simulate the groove on the brake disc rotor. This grooves can be a result of worn out brake pads. Grooves of 1.2 mm is made on the brake disc rotor by using lathe machine and the measurements of such grooves was made by using Clay paste as shown on Figure 9.

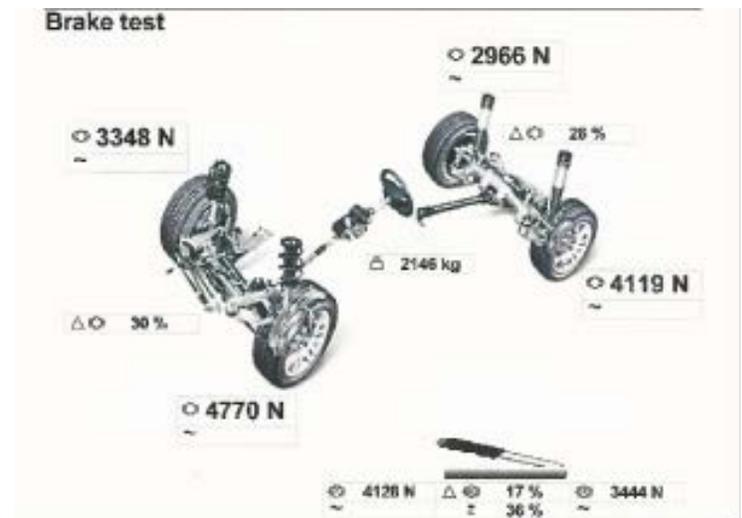
Figure 9: Brake test for grooved modified disc brake

Following the modification that was made to simulate fault in disc brake rotor grooves, the results showed that the brake force difference-service brake ( $\Delta$ ) test for the front axle and the rear axle is between 28 to 30%, which exceed the allowed limits of 25 %. Also the force difference between the right and left wheels for the front axle which is (1422 N), and the force difference between the right and left wheels for the rear axle is (1153 N). From Figure 10, Front axle chart showed peak brake forces that bring the vehicle to complete stop were nearly 3400 N on the left brake side and 2300 N on the right brake side. Whereas the Rear axle chart showed peak brake forces that bring the vehicle to complete stop were nearly 4300 N on the left brake side and 3000 N on the right brake. All of these results indicate big difference that could lead to unbalanced force system.

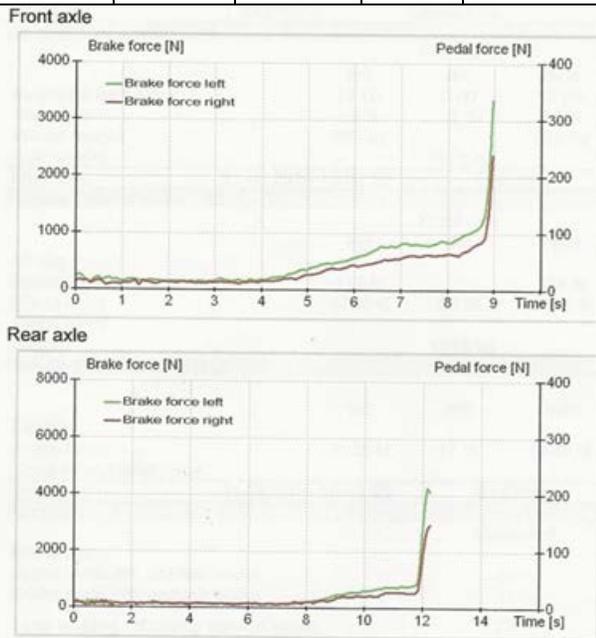
**Figure 10: Charts results for grooved modified disc brake**
